CONVEYING DUSTY CERAMIC PARTS

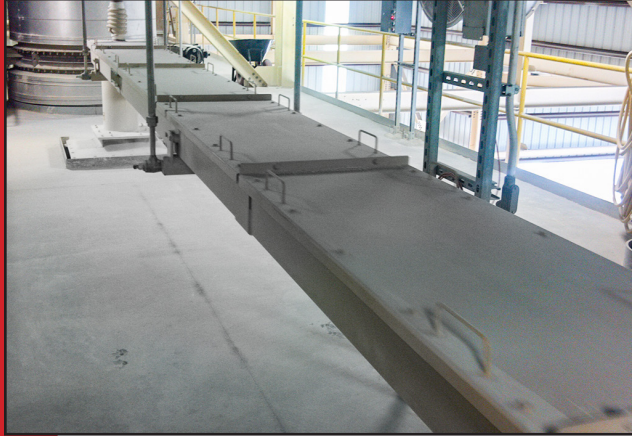
A Slipstick horizontal motion conveyor was recommended. Because the horizontal motion conveyor commonly consists of a one-piece, seamless pan riding on suspension points spaced periodically along its length, both the pan's interior and exterior surface can be easily accessed for wipe-downing cleaning. There are no support frames or springs under the conveyor pan (which would introduce cracks, crevices or other dust collecting places) that need to be cleaned. The producer replaced the belt conveyor with a Slipstick horizontal motion conveyor. Because the conveyor's entire drive unit is totally enclosed and could be located at one end, the conveyor's moving parts are not exposed to dust.
